**769 QUEEN STREET EAST
ST. MARY'S, ONTARIO
TREE ASSESSMENT REPORT
FOR ZBA**

PREPARED BY: RON KOUDYS LANDSCAPE
ARCHITECTS INC

DATE: JULY, 2022

RKLA PROJECT #: 22-200

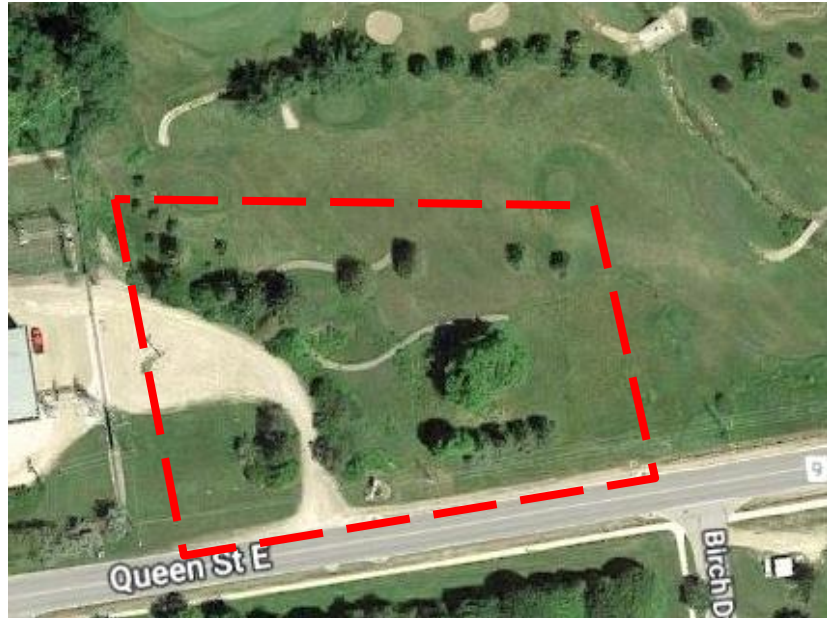
Figure 1 - Image capture from Google Earth
Red dashed line - limit of tree inventory

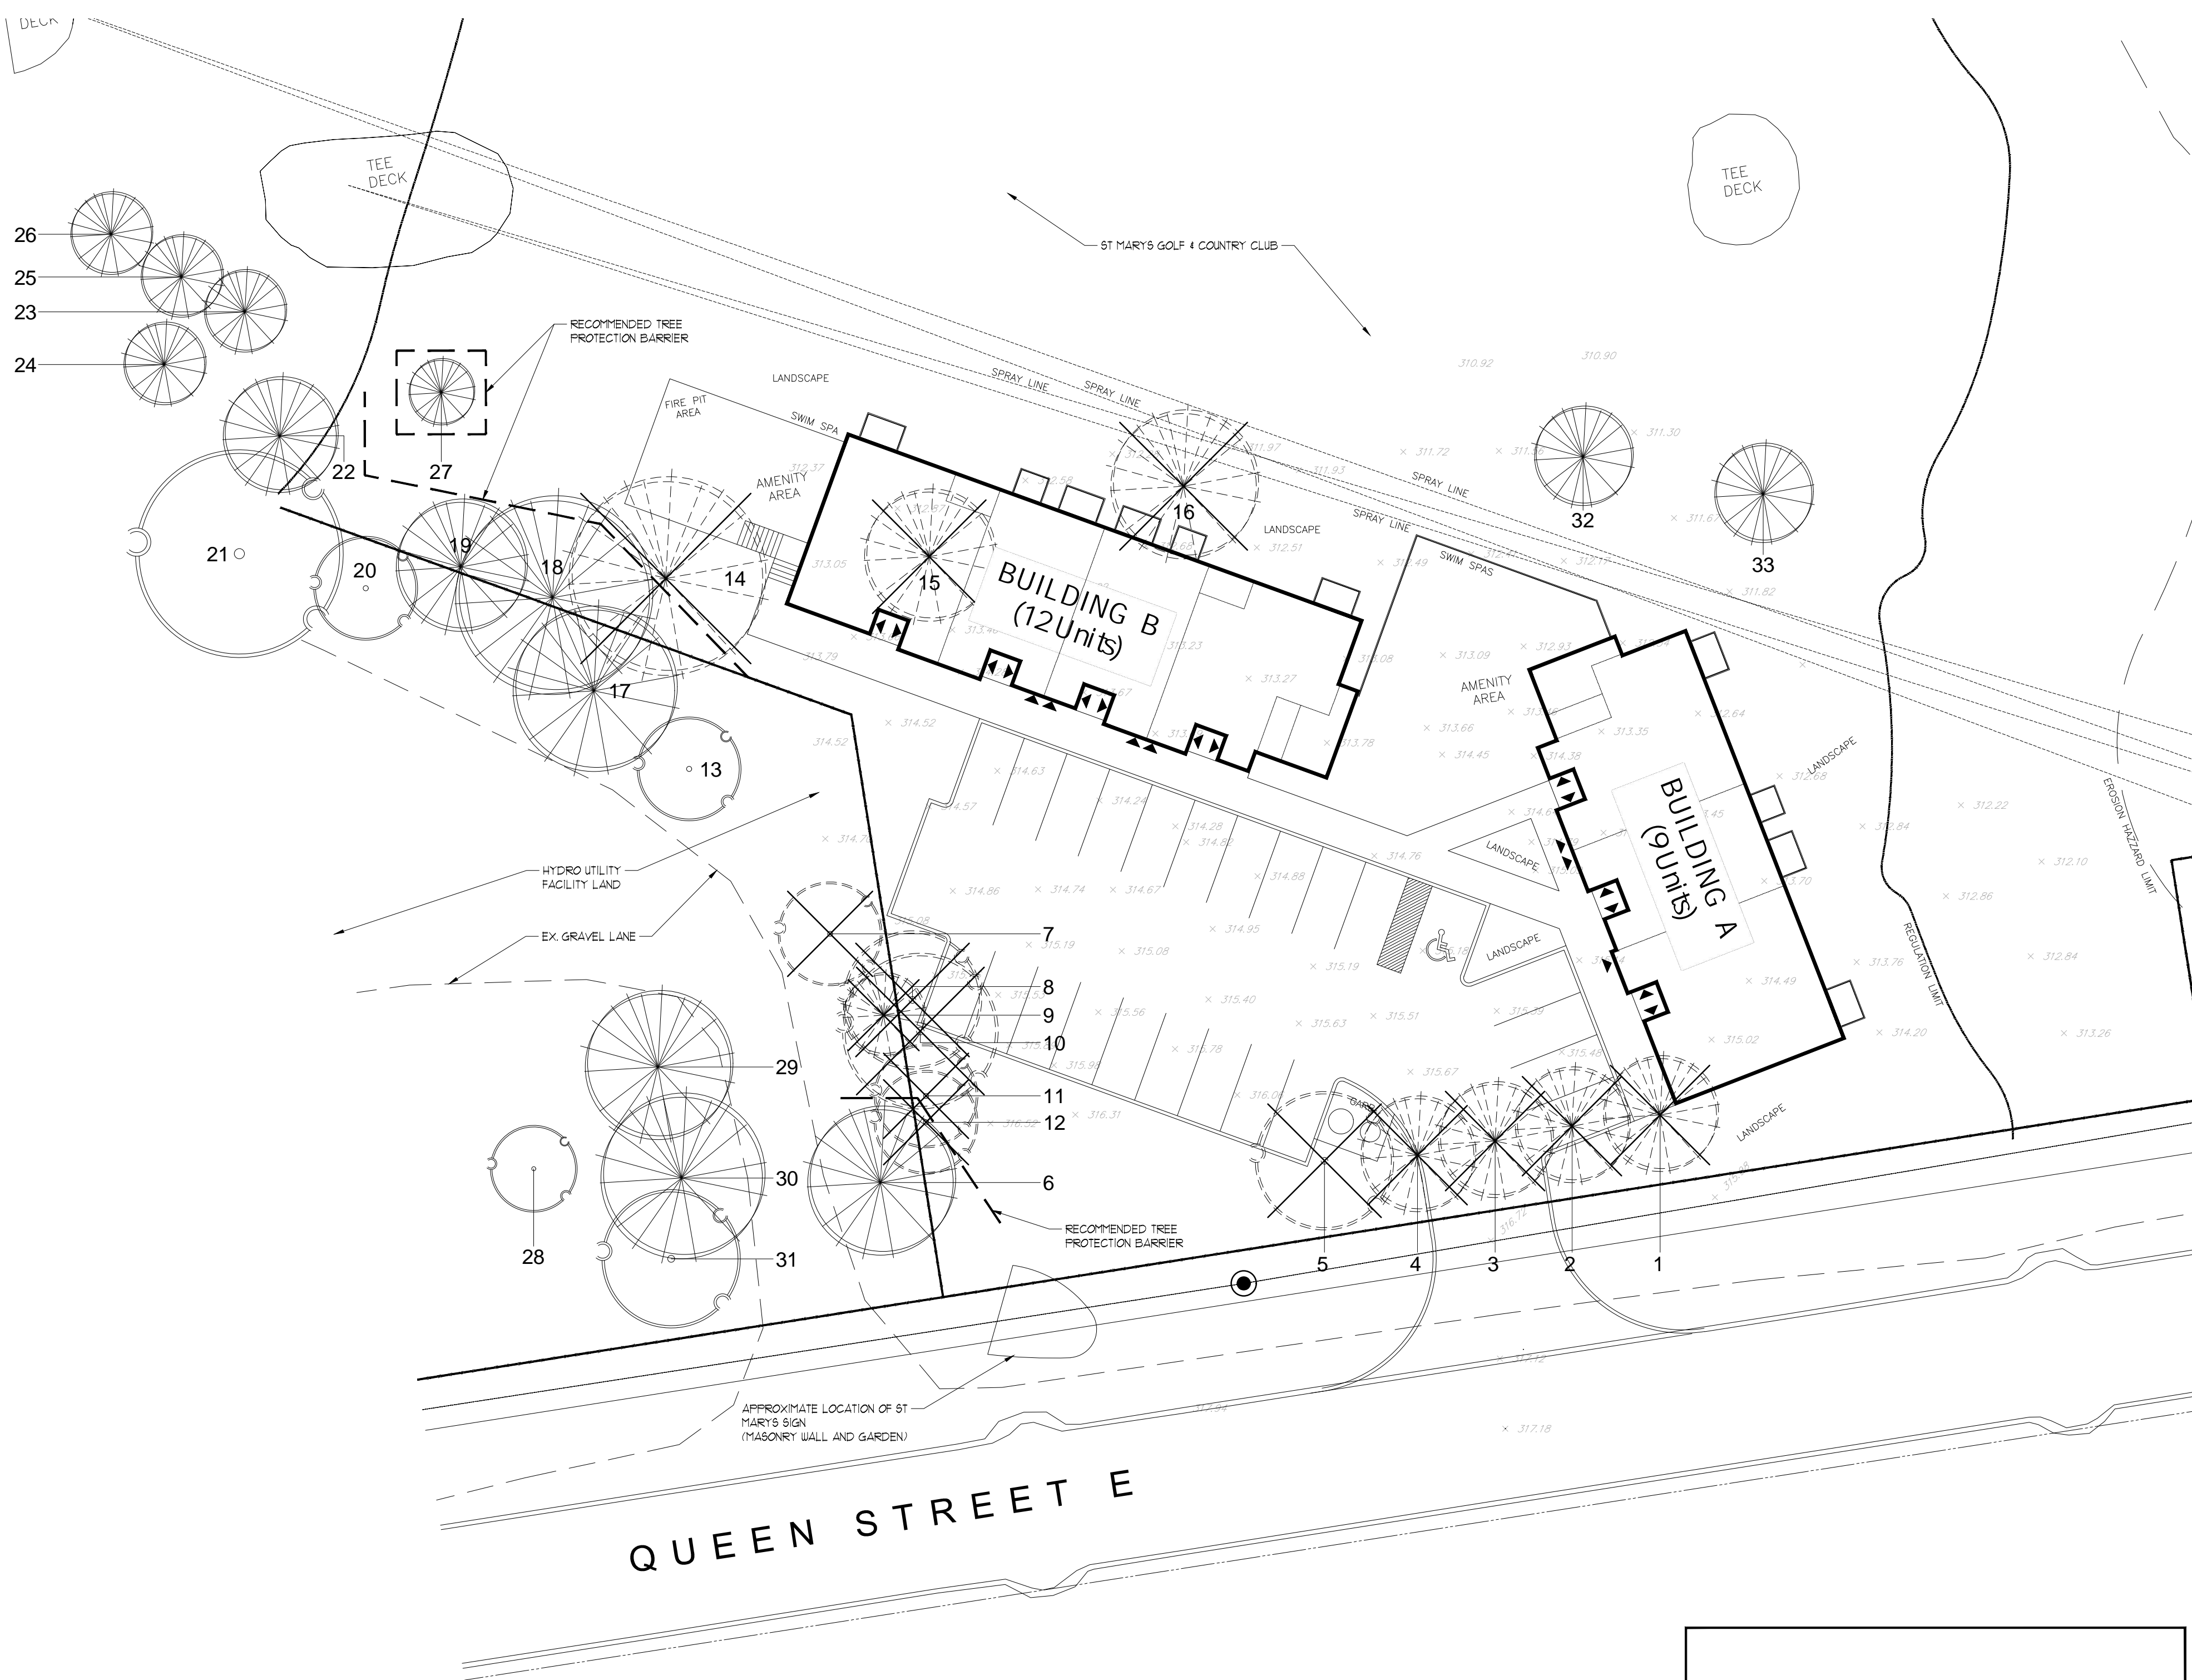
TREE PRESERVATION PLAN
SCALE = 1:250

TREES RECOMMENDED FOR REMOVAL (14 TREES)

ID#	GENERAL INFORMATION		SIZE	HEALTH & CONDITION		RECOMMENDATIONS						
	BOTANICAL NAME	COMMON NAME		LOCATION	COMMENTS	EXPECTED CONSTRUCTION IMPACTS	PRESERVE OR REMOVE	IMPACT MITIGATION or REMOVAL RATIONALE (TP = tree protection)				
1	<i>Picea pungens</i> var. <i>glauca</i>	Colorado Blue Spruce	Subject site	-30	35	5	good	good	Branches to grade, minor thinning	Conflict with proposed building A	remove	construction impacts
2	<i>Picea pungens</i> var. <i>glauca</i>	Colorado Blue Spruce	Subject site	-25	35	5	good	good	Branches to grade, minor thinning	Conflict with proposed parking	remove	construction impacts
3	<i>Picea pungens</i> var. <i>glauca</i>	Colorado Blue Spruce	Subject site	-30	35	5	good	good	Branches to grade, minor thinning	Conflict with proposed parking	remove	construction impacts
4	<i>Picea pungens</i> var. <i>glauca</i>	Colorado Blue Spruce	Subject site	-30	35	5	good	good	Branches to grade, minor thinning	Conflict with proposed parking	remove	construction impacts

5	<i>Acer saccharum</i>	Sugar Maple	Subject site	60	4	5	poor	fair	Significant scaffold branch loss, significant epicormic growth, fused branches, tight unions with included bark, pruned for hydro line clearance.	Conflict with proposed parking	remove	construction impacts
7	<i>Juglans nigra</i>	Black Walnut	Hydro utility facility	21	3	5	far	poor	low branched, on slope, significant trunk damage, deep old trunk wounds	none	remove	poor structural integrity tree adjacent to proposed parking - consent from land owner required
8	<i>Thuja occidentalis</i>	White Cedar	Hydro utility facility	16, 15, 10	25	5	far	far	Multistem 5, fully dead, drooping branches, trunk rot, invasive species	Conflict with proposed parking	remove	construction impacts & invasive species
9	<i>Thuja occidentalis</i>	White Cedar	Hydro utility facility	16, 15, 10	25	5	far	far	Multistem 3, included bark with seam at primary union, dense understory	Conflict with proposed parking	remove	construction impacts - consent from land owner required

10	<i>Thuja occidentalis</i>	White Cedar	Hydro utility facility	16, 15, 10	25	5	far	far	Heavily suppressed, dead wood, invasive species	Conflict with proposed parking	remove	construction impacts
11	<i>Thuja occidentalis</i>	White Cedar	Hydro utility facility	13, 7, 3	2	2	far	far	Multistem 3, suppressed, dead wood, invasive species	none	remove	invasive species
12	<i>Thuja occidentalis</i>	White Cedar	Hydro utility facility	15, 15, 3	4	4	far	far	Multistem 2, suppressed, invasive species	none	remove	invasive species
14	<i>Picea abies</i>	Norway Spruce	Subject site	64	6	5	far	far	codominant leaders with buttressing at union	Conflict with proposed amenity area	remove	construction impacts
15	<i>Thuja occidentalis</i>	White Cedar	Subject site	-70	4	5	good	good	Nearly branched to grade, clustered primary union, DBH taken below low primary union	Conflict with proposed building B	remove	construction impacts

16	<i>Thuja occidentalis</i>	White Cedar	Subject site	-65	4	5	good	good	Nearly branched to grade, DBH taken below low primary union	Conflict with proposed building B	remove	construction impacts

TREES RECOMMENDED FOR PRESERVATION (19 TREES)

ID#	GENERAL INFORMATION		SIZE	HEALTH & CONDITION		RECOMMENDATIONS						
	BOTANICAL NAME	COMMON NAME		LOCATION	COMMENTS	EXPECTED CONSTRUCTION IMPACTS	PRESERVE OR REMOVE	IMPACT MITIGATION or REMOVAL RATIONALE (TP = tree protection)				
6	<i>Pinus nigra</i>	Austrian Pine	Hydro utility facility	-35	45	4	far	good	central leader gone, insect damage to trunk, on slope	none	preserve	TP barrier
13	<i>Juglans nigra</i>	Black Walnut	Hydro utility facility	17	3	5	good	good	low branched, thin canopy	none	preserve	none
17	<i>Thuja occidentalis</i>	White Cedar	Hydro utility facility	-65, 40	5	5	far	far	Multistem 2, nearly branched to grade, primary union at grade, loose crown, on slope	none	preserve	TP barrier
18	<i>Picea abies</i>	Norway Spruce	Subject site	49	6	5	good	good	Loose crown	potential conflict with site grading	preserve	TP barrier
19	<i>Picea glauca</i>	White Spruce	Subject site	36	4	3	good	good	Sparsely crown, dead lower branches	potential conflict with site grading	preserve	TP barrier

20	<i>Juglans nigra</i>	Black Walnut	Hydro utility facility	12, 15	3	5	far	far	Multistem 2, low branched, included bark at primary union	none	preserve	TP barrier
21	<i>Juglans nigra</i>	Black Walnut	Hydro utility facility	37	6	5	good	good	soil/gravel piled at base of tree	none	preserve	TP barrier
22	<i>Picea glauca</i>	White Spruce	Subject site	35	3	1	good	far	fully dead	none	preserve	TP barrier
23	<i>Picea abies</i>	Norway Spruce	Subject site	15	25	5	good	good	Full form, branched to grade	none	preserve	none
24	<i>Picea abies</i>	Norway Spruce	Subject site	10	25	5	good	good	Full form, branched to grade	none	preserve	none
25	<i>Picea abies</i>	Norway Spruce	Subject site	13	25	5	good	good	Full form, branched to grade	none	preserve	none
26	<i>Picea abies</i>	Norway Spruce	Subject site	13	25	5	good	good	Full form, branched to grade	none	preserve	none
27	<i>Picea abies</i>	Norway Spruce	Subject site	11	2	5	good	good	Full form, a bit thin	none	preserve	TP barrier

28	<i>Acer glaberrimum</i>	Norway Maple	Hydro utility facility	33	25	2	poor	poor	Moribund, rot at primary union, significant dead wood and snags	none	preserve	none
29	<i>Pinus nigra</i>	Austrian Pine	Hydro utility facility	38	45	5	good	good	Minor dead lower branches, sparse crown	none	preserve	none
30	<i>Pinus nigra</i>	Austrian Pine	Hydro utility facility	42, 36	5	5	far	far	Multistem 2, bulge at primary union with included bark	none	preserve	none
31	<i>Acer saccharum</i>	Sugar Maple	Hydro utility facility	19, 10	4	5	far	far	Multistem 2, primary union below grade, codominant leaders	none	preserve	none
32	<i>Picea abies</i>	Norway Spruce	Subject site	-15	3	5	good	good	Branches to grade, full form	none	preserve	none
33	<i>Picea abies</i>	Norway Spruce	Subject site	-15	3	6	good	good	Branches to grade, full form	none	preserve	none
