**769 QUEEN STREET EAST
ST. MARY'S, ONTARIO
TREE ASSESSMENT REPORT
FOR ZBA**

PREPARED BY: RON KOUDYS LANDSCAPE
ARCHITECTS INC

DATE: JULY, 2022

RKLA PROJECT #: 22-200

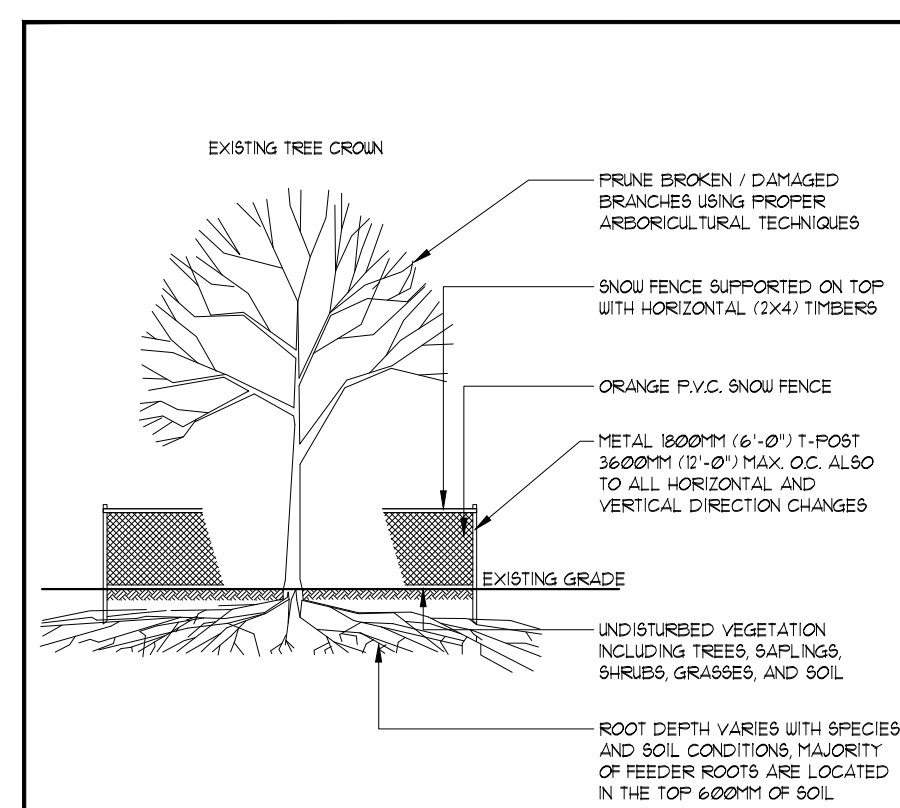
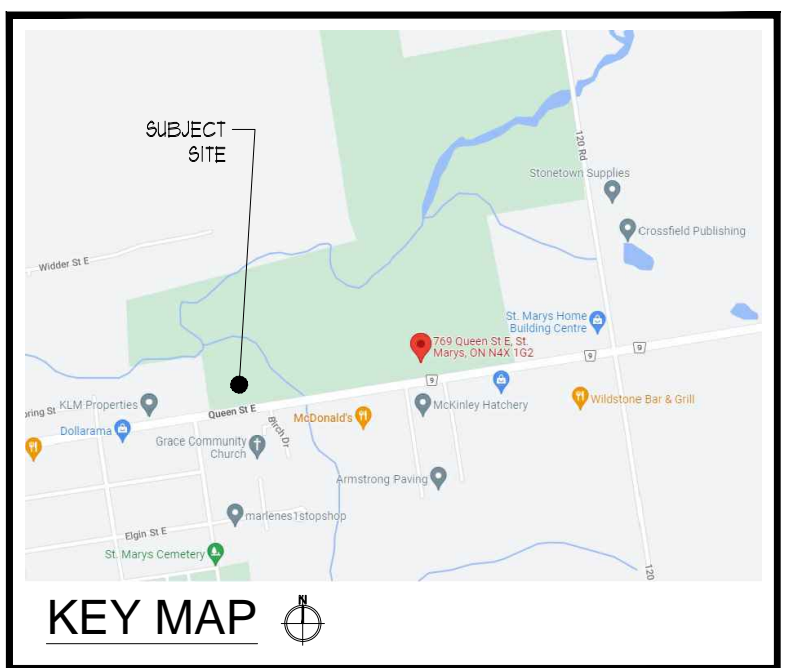
TREE PRESERVATION PLAN
SCALE = 1:250

20	<i>Juglans nigra</i>	Black Walnut	Hydro utility facility	12, 15	3	5	far	far	Multistem 2, low branched, included bark at primary union	none	preserve	TP barrier
21	<i>Juglans nigra</i>	Black Walnut	Hydro utility facility	37	6	5	good	good	soil/gravel piled at base of tree	none	preserve	TP barrier
22	<i>Picea glauca</i>	White Spruce	Subject site	35	3	1	good	far	fully dead	none	preserve	TP barrier
23	<i>Picea abies</i>	Norway Spruce	Subject site	15	25	5	good	good	Full form, branched to grade	none	preserve	none
24	<i>Picea abies</i>	Norway Spruce	Subject site	10	25	5	good	good	Full form, branched to grade	none	preserve	none
25	<i>Picea abies</i>	Norway Spruce	Subject site	13	25	5	good	good	Full form, branched to grade	none	preserve	none
26	<i>Picea abies</i>	Norway Spruce	Subject site	13	25	5	good	good	Full form, branched to grade	none	preserve	none
27	<i>Picea abies</i>	Norway Spruce	Subject site	11	2	5	good	good	Full form, a bit thin	none	preserve	TP barrier

28	<i>Acer glaberrimum</i>	Norway Maple	Hydro utility facility	33	25	2	poor	poor	Moribund, rot at primary union, significant dead wood and snags	none	preserve	none
29	<i>Pinus nigra</i>	Austrian Pine	Hydro utility facility	38	45	5	good	good	Minor dead lower branches, sparse crown	none	preserve	none
30	<i>Pinus nigra</i>	Austrian Pine	Hydro utility facility	42, 36	5	5	far	far	Multistem 2, bulge at primary union with included bark	none	preserve	none
31	<i>Acer saccharum</i>	Sugar Maple	Hydro utility facility	19, 10	4	5	far	far	Multistem 2, primary union below grade, codominant leaders	none	preserve	none
32	<i>Picea abies</i>	Norway Spruce	Subject site	-15	3	5	good	good	Branches to grade, full form	none	preserve	none
33	<i>Picea abies</i>	Norway Spruce	Subject site	-15	3	6	good	good	Branches to grade, full form	none	preserve	none
